Subject: Anode breaking

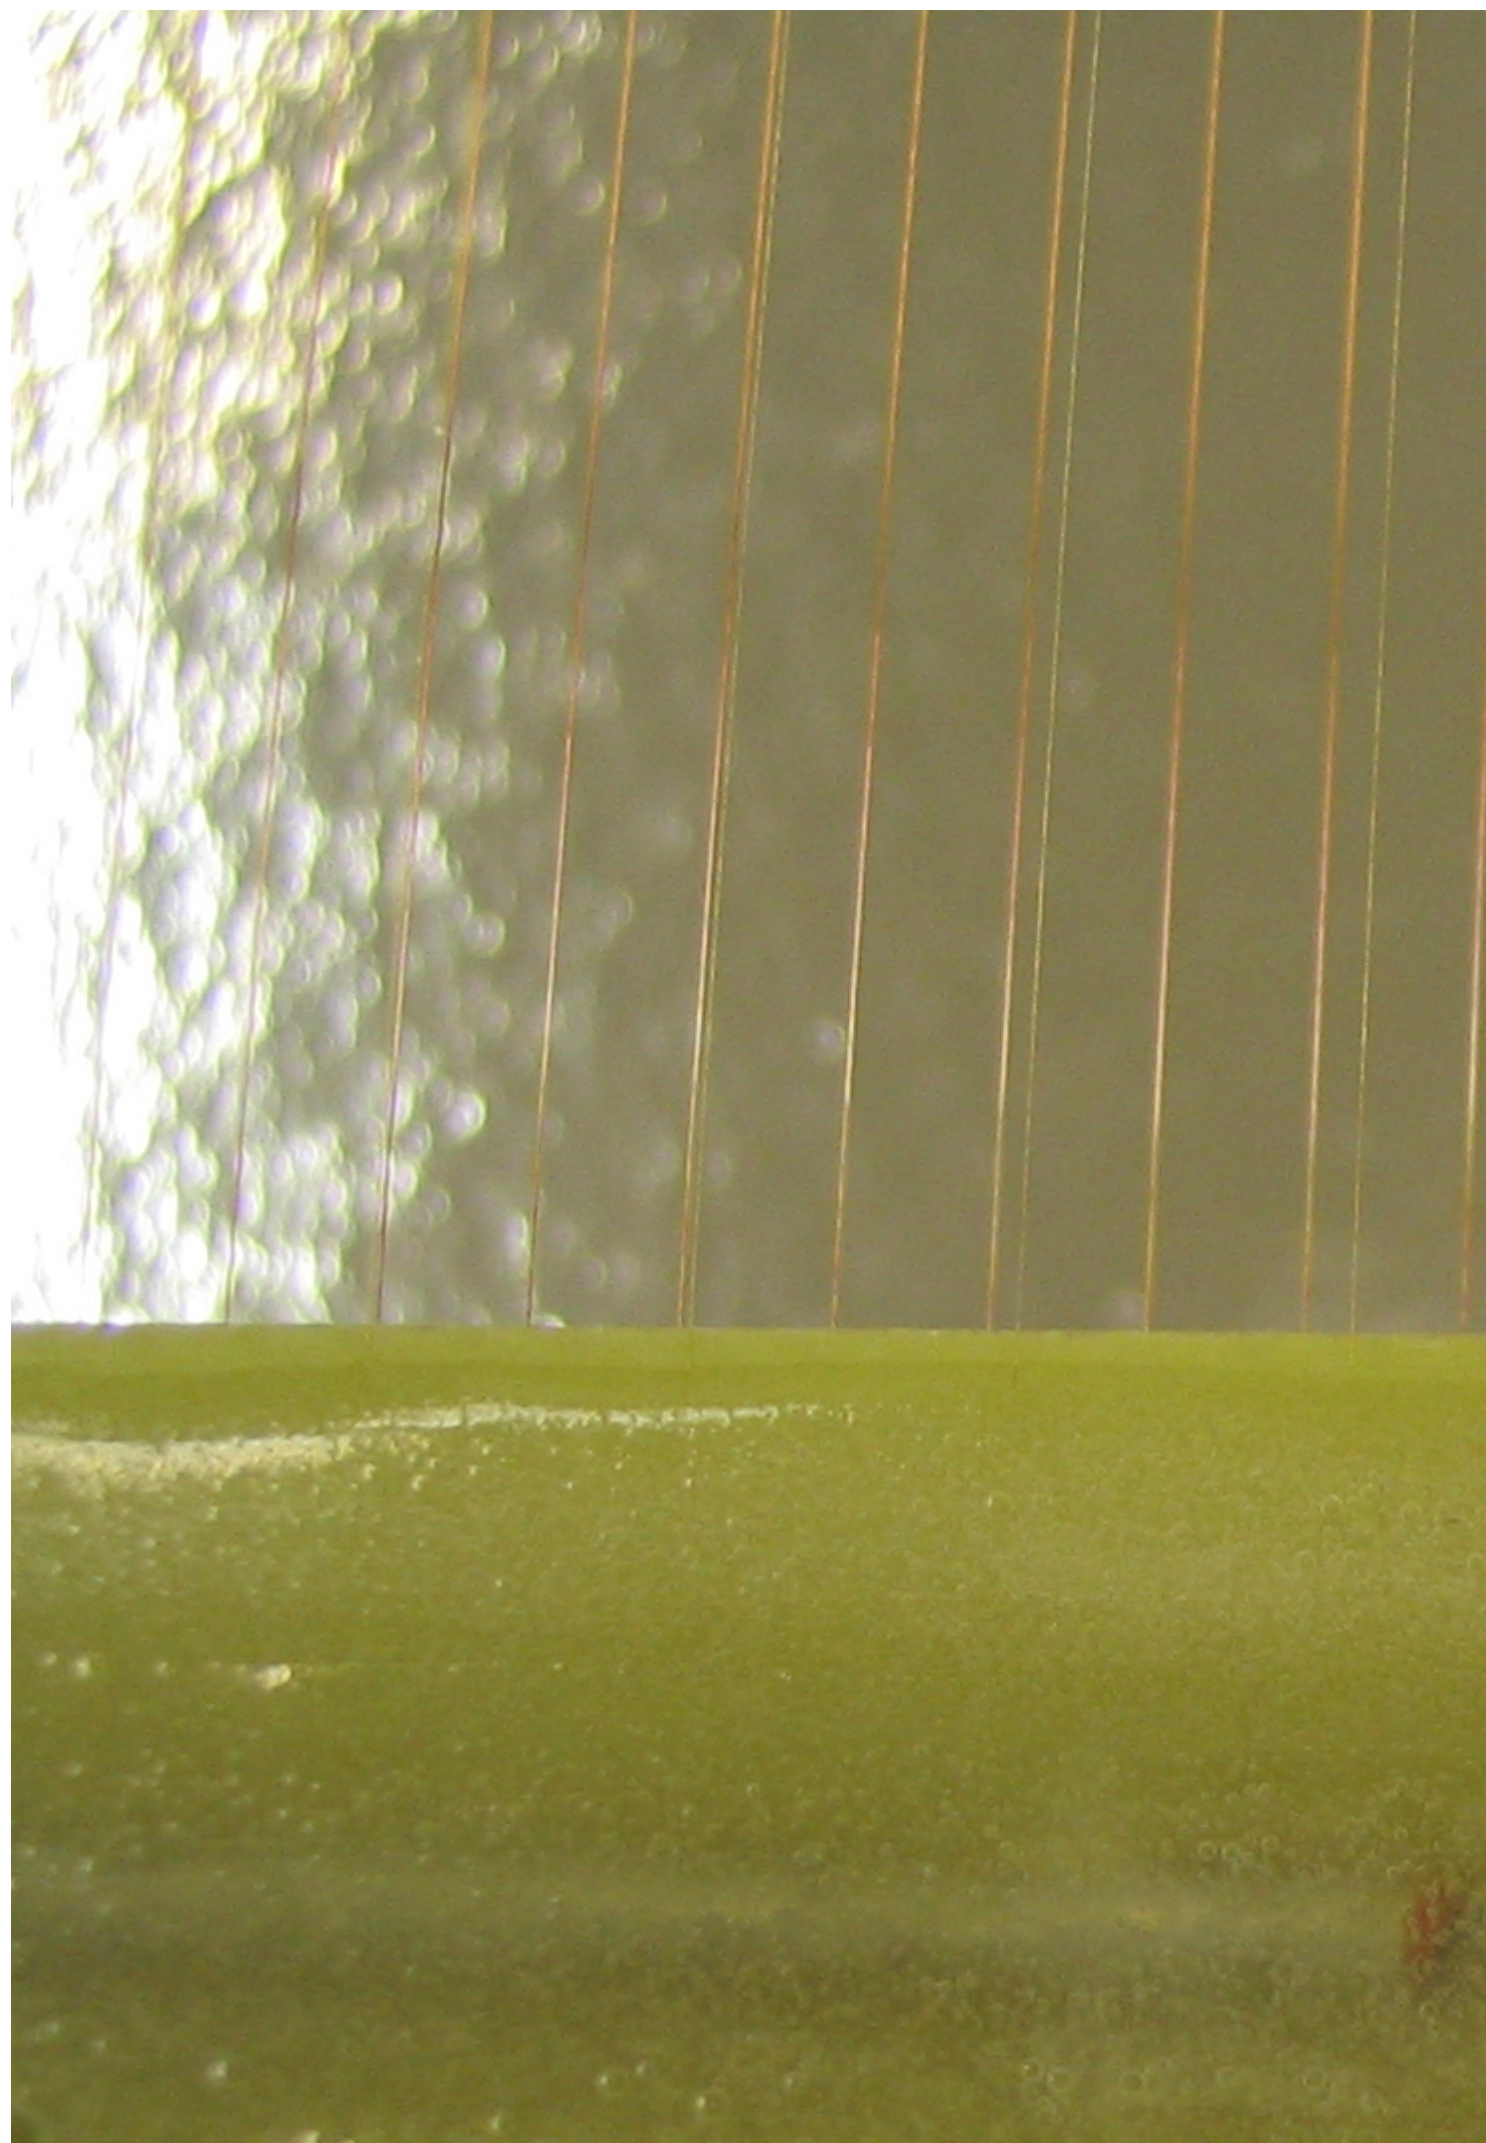
1) [IMG_0530.JPG](#), downloaded 1262 times

I repaired those unconnected wires, by pulling a piece of anode wire under the unconnected wires and their next connected neighbor and contacting with silver epoxy (see picture).

Afterwards, of course covering everything with glue again for isolation. That is a bit tricky, but

significantly easier, that scraping away all the glue and starting to try to solder again.
