Subject: Cathode Wire Quality
Posted by Christian Lippmann on Tue, 18 May 2004 14:31:19 GMT
View Forum Message <> Reply to Message

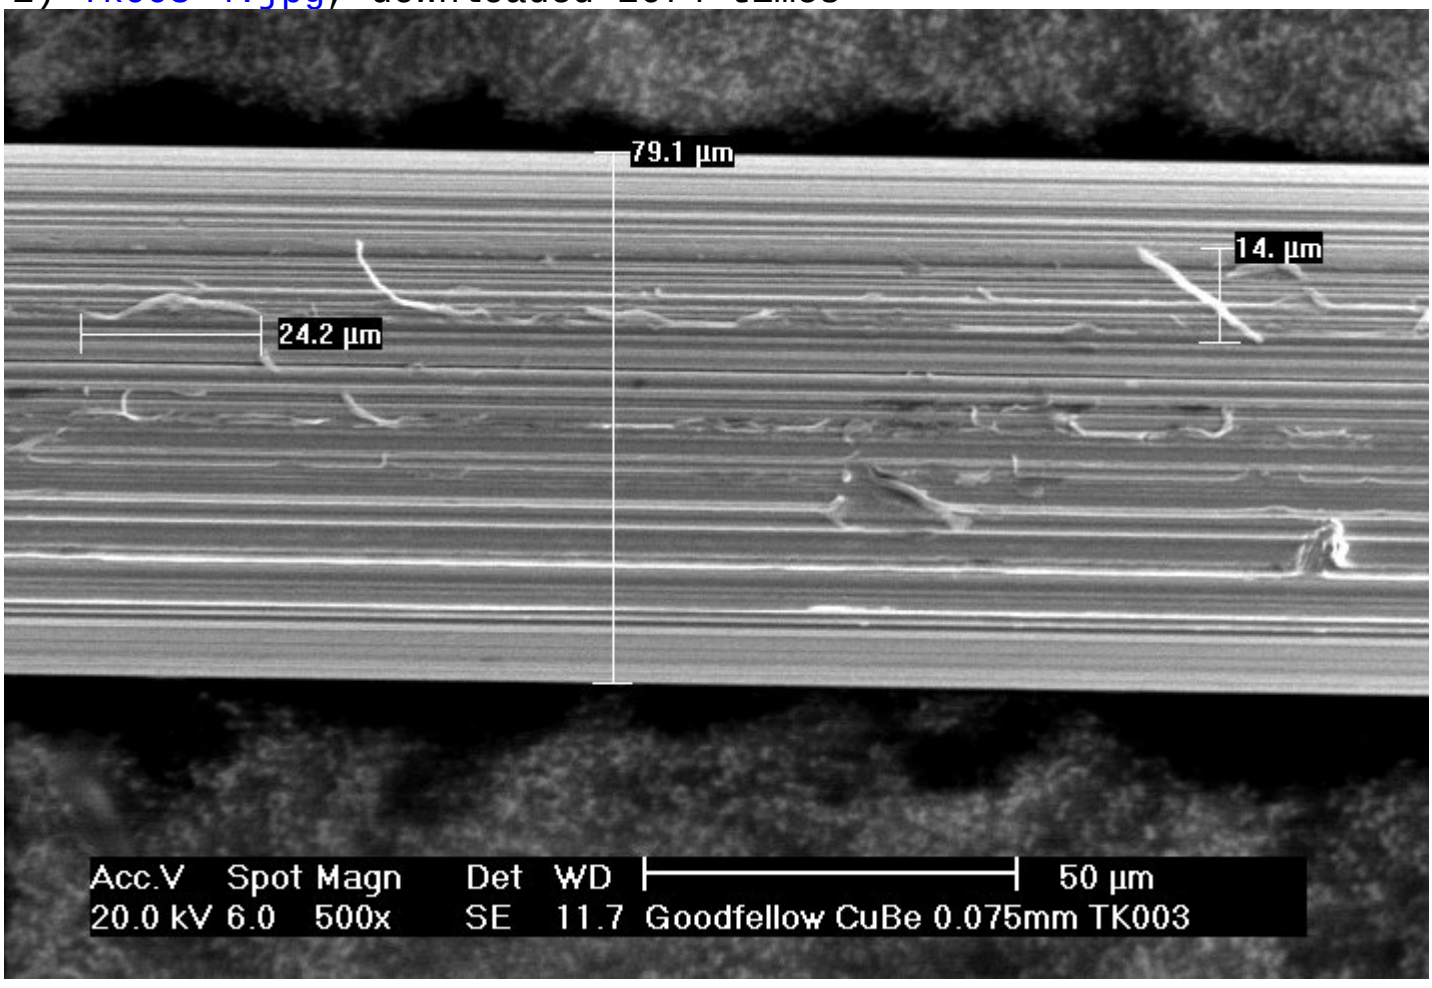
1) Tk003-4.jpg, downloaded 2674 times

TK003: Some grooves are visible and pieces of metal sticking out, which is not nice. However, some people claim that one could live with a wire like that. The visible marks are probably due to an overused drawing die. Usually they are visible only on one side of the wire.
