Subject: Cathode Wire Quality
Posted by Christian Lippmann on Tue, 18 May 2004 14:31:19 GMT
View Forum Message <> Reply to Message

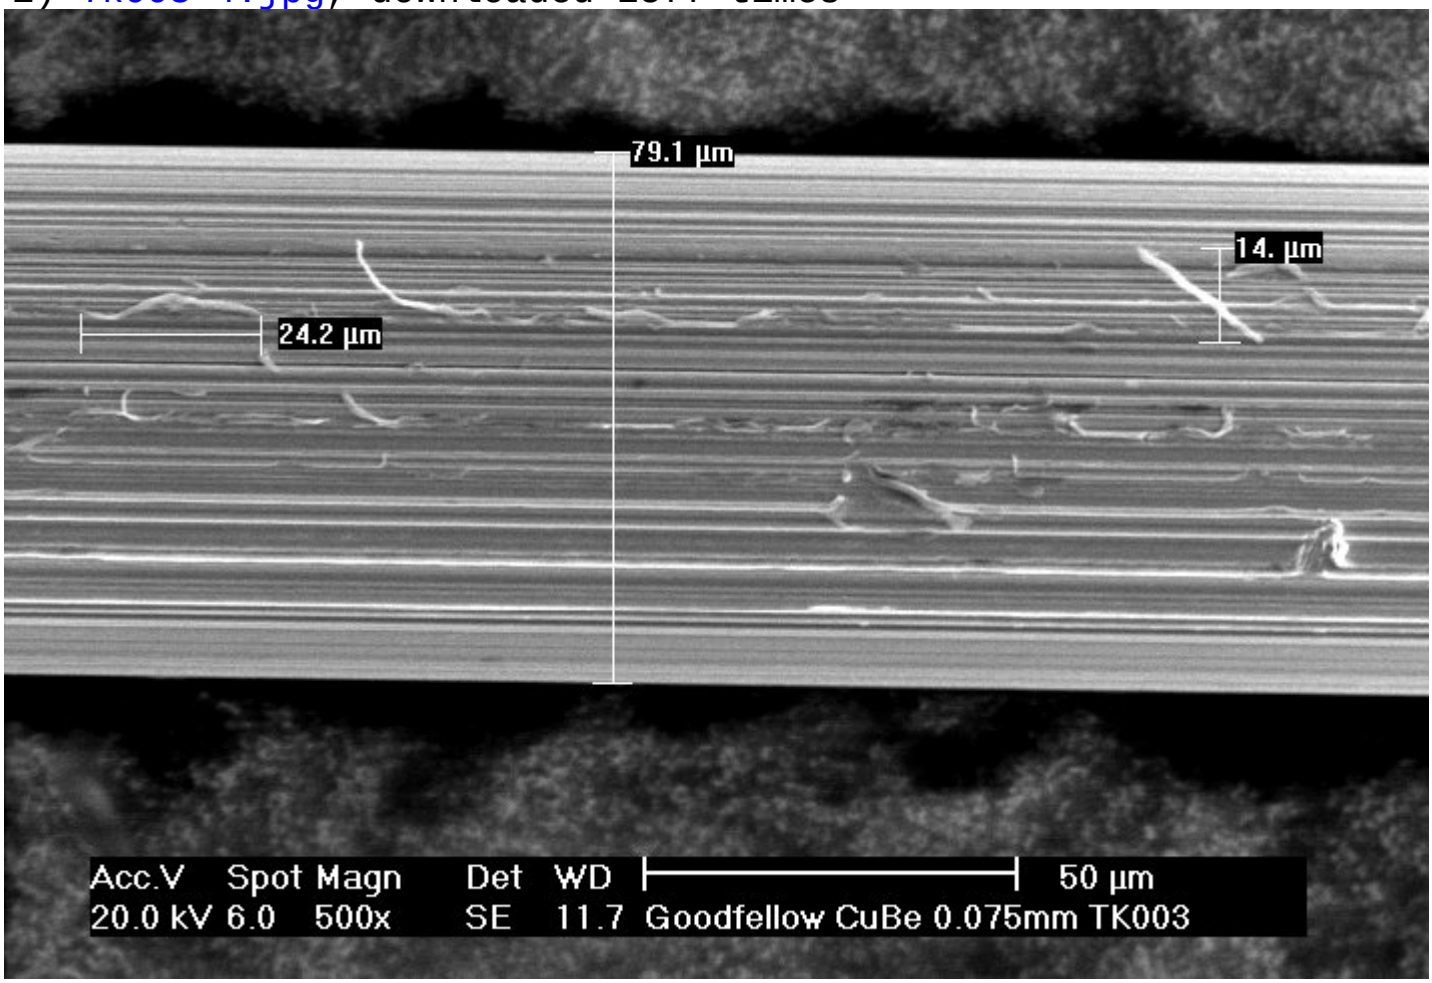
1) Tk003-4.jpg, downloaded 2577 times

TK003: Some grooves are visible and pieces of metal sticking out, which is not nice. However, some people claim that one could live with a wire like that. The visible marks are probably due to an overused drawing die. Usually they are visible only on one side of the wire.
