Subject: Re: Anode breaking Posted by Clemens Adler on Thu, 19 Aug 2004 15:42:09 GMT View Forum Message <> Reply to Message

and another update on the anode breaking problem.

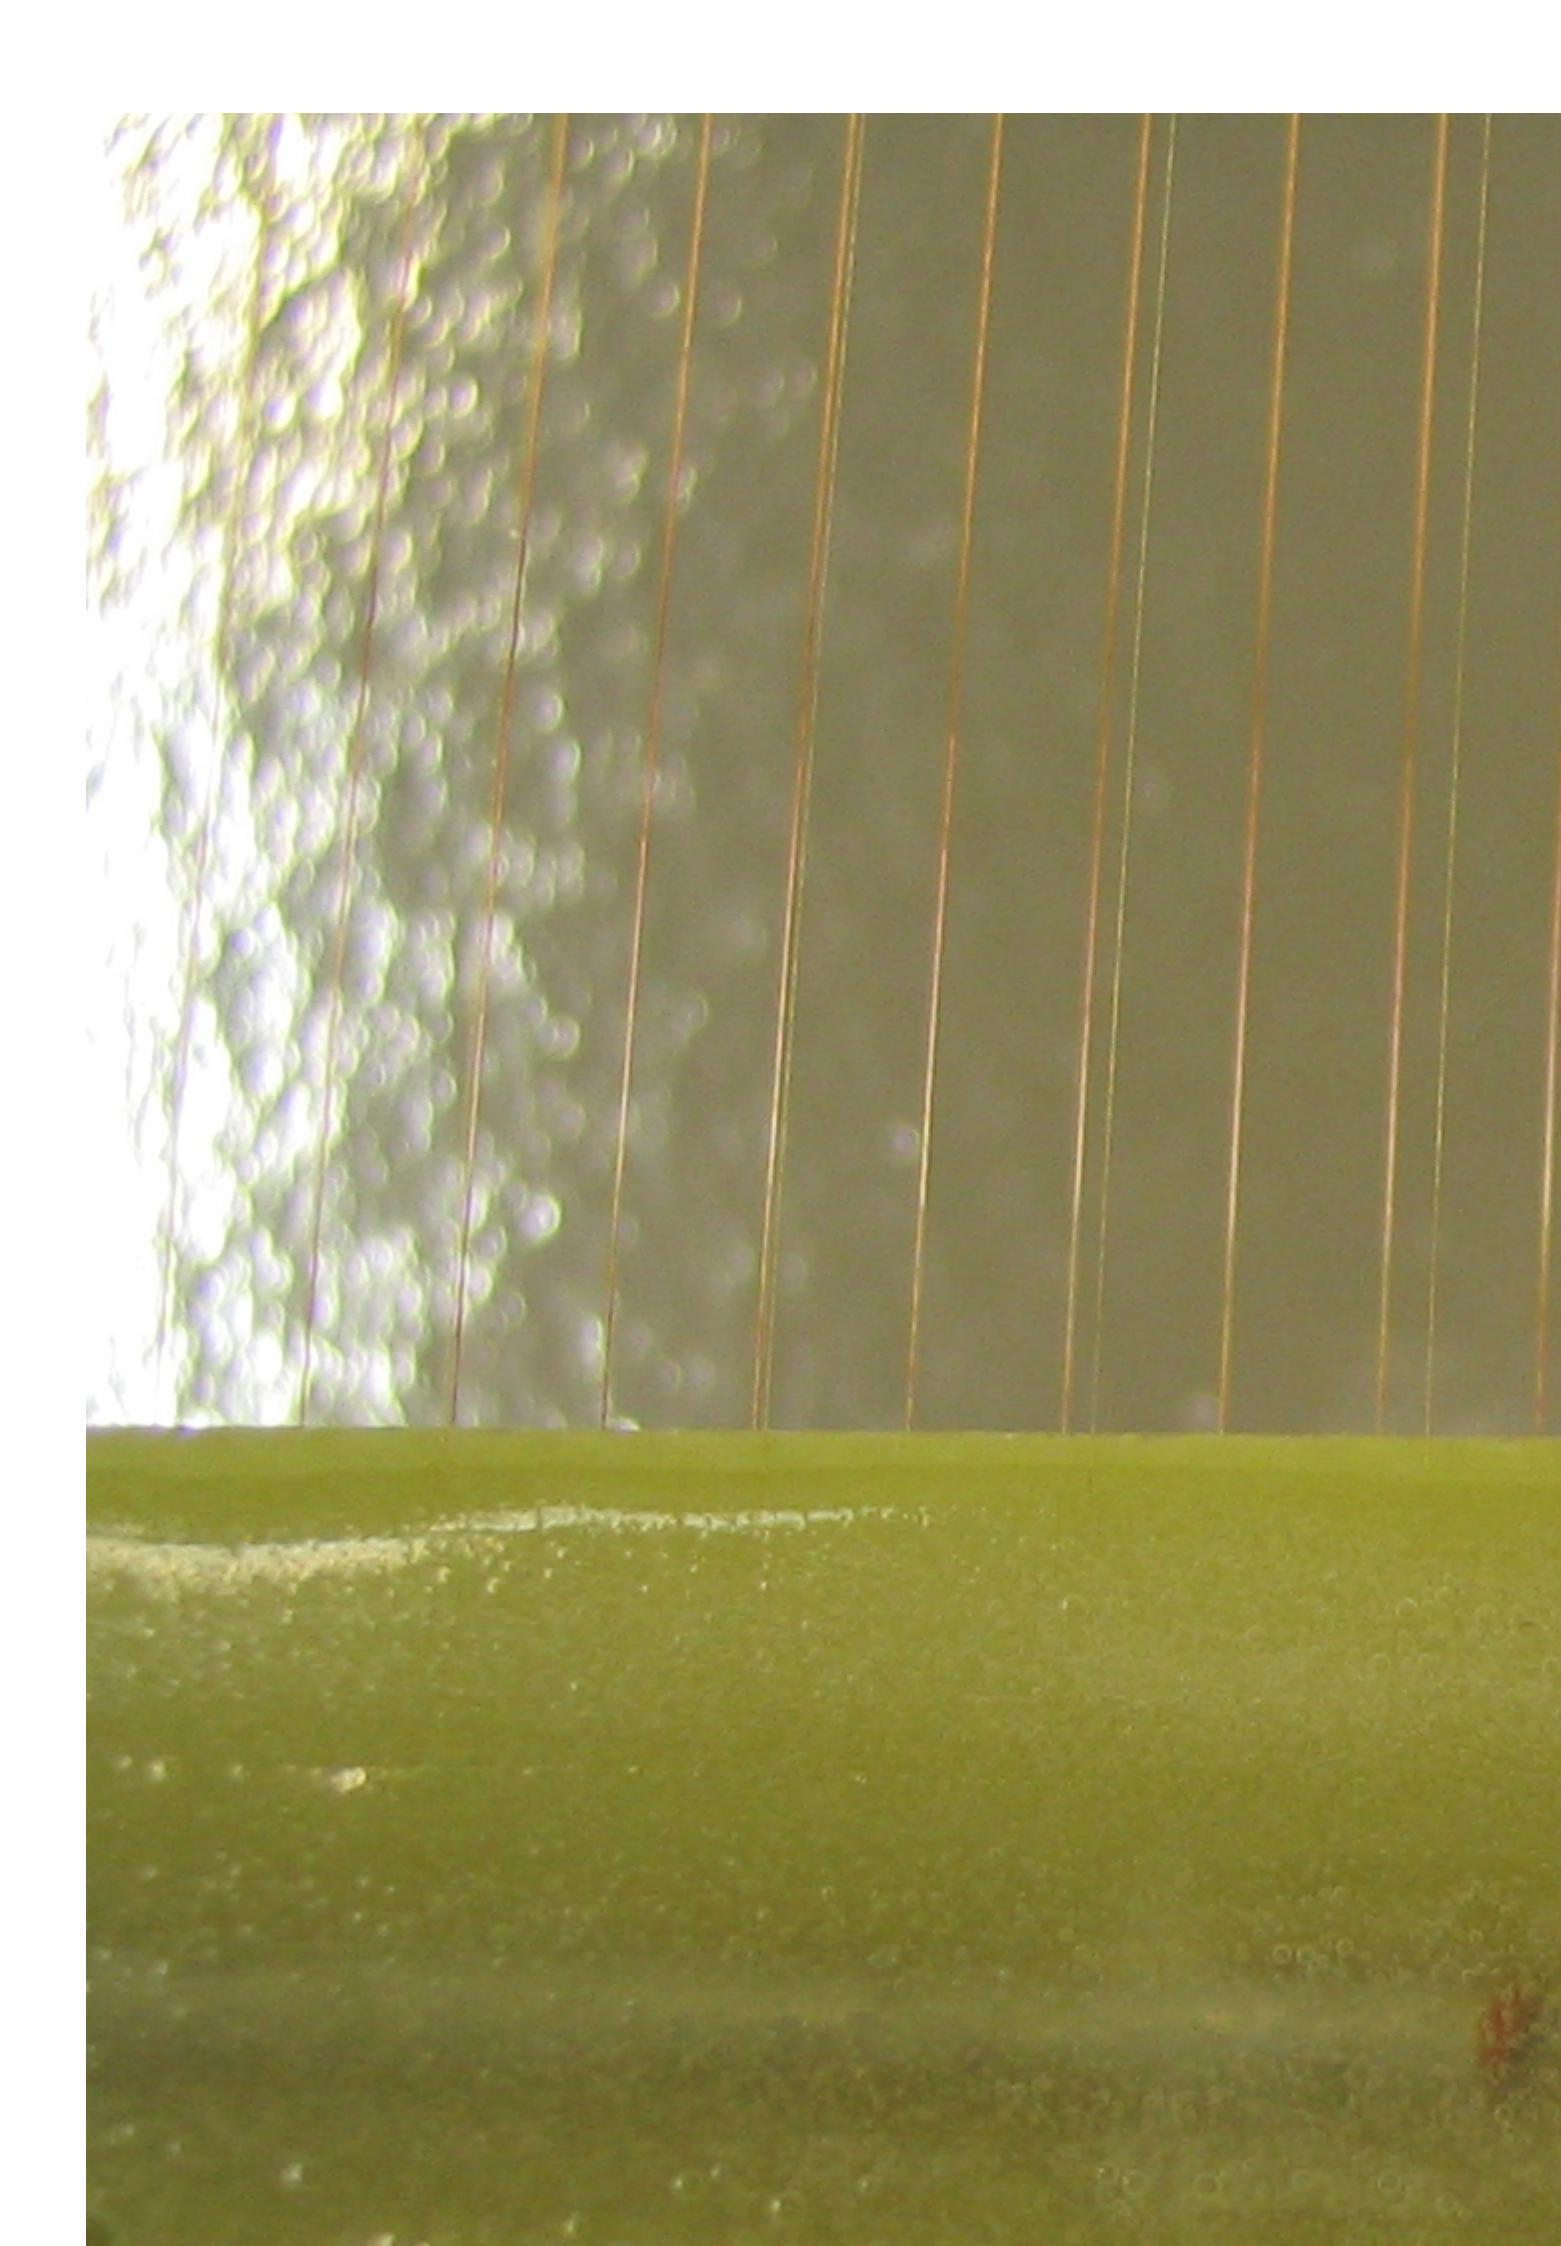
File Attachments
1) IMG_0530.JPG, downloaded 1260 times

1 Chamber has 2 broken wires where the HV cable is soldered to the Anode segment contact strip,

1 Chamber has 2x2 broken wires at the beginning of the anode segment (chamber turning problem?!?).

I repaired those unconnected wires, by pulling a piece of anode wire under the unconnected wires and their next connected neighbor and contacting with silver epoxy (see picture). Afterwards, of course covering everything with glue again for isolation. That is a bit tricky, but significantly easier, that scraping away all the glue and starting to try to solder again.
